*EVALUATION OF THE CAPABILITY OF THE
SURFACE CONDITION ANALYZER (SCAN)
SENSORS TO MEASURE RUNWAY WATER DEPTH*

Calspan Report No. 6857-M-1

TECHNICAL REPORT

January 1986

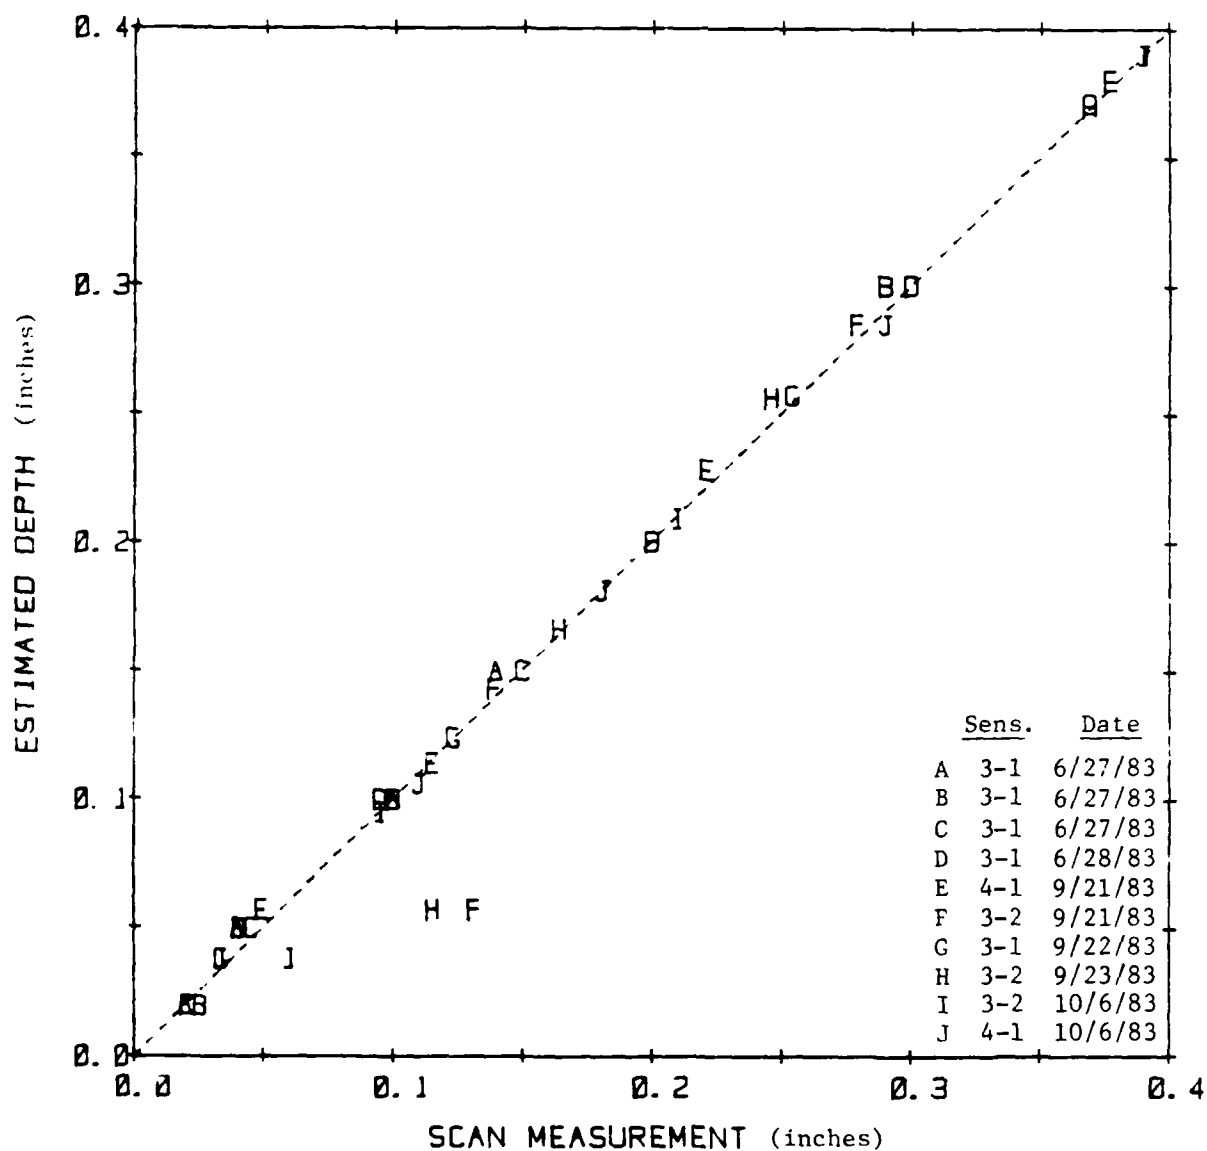
Figure 1

CALIBRATION RESULTS OF THE THREE SCAN WATER DEPTH SENSORS
AFTER INSTALLATION AT SPIRIT OF ST. LOUIS AIRPORT.

The calibration data (Figure 1) show that for near static conditions the sensors accurately measured water depth over the range 0.03-0.40 inches. Sensor 3-2 was an exception at depths below 0.1 inches, and its inability to measure correctly at low depth values may have been related to the problem of the sloping sensor surface as noted in the laboratory. Note that the calibration of Sensor 3-1 did not change between the June and September data.

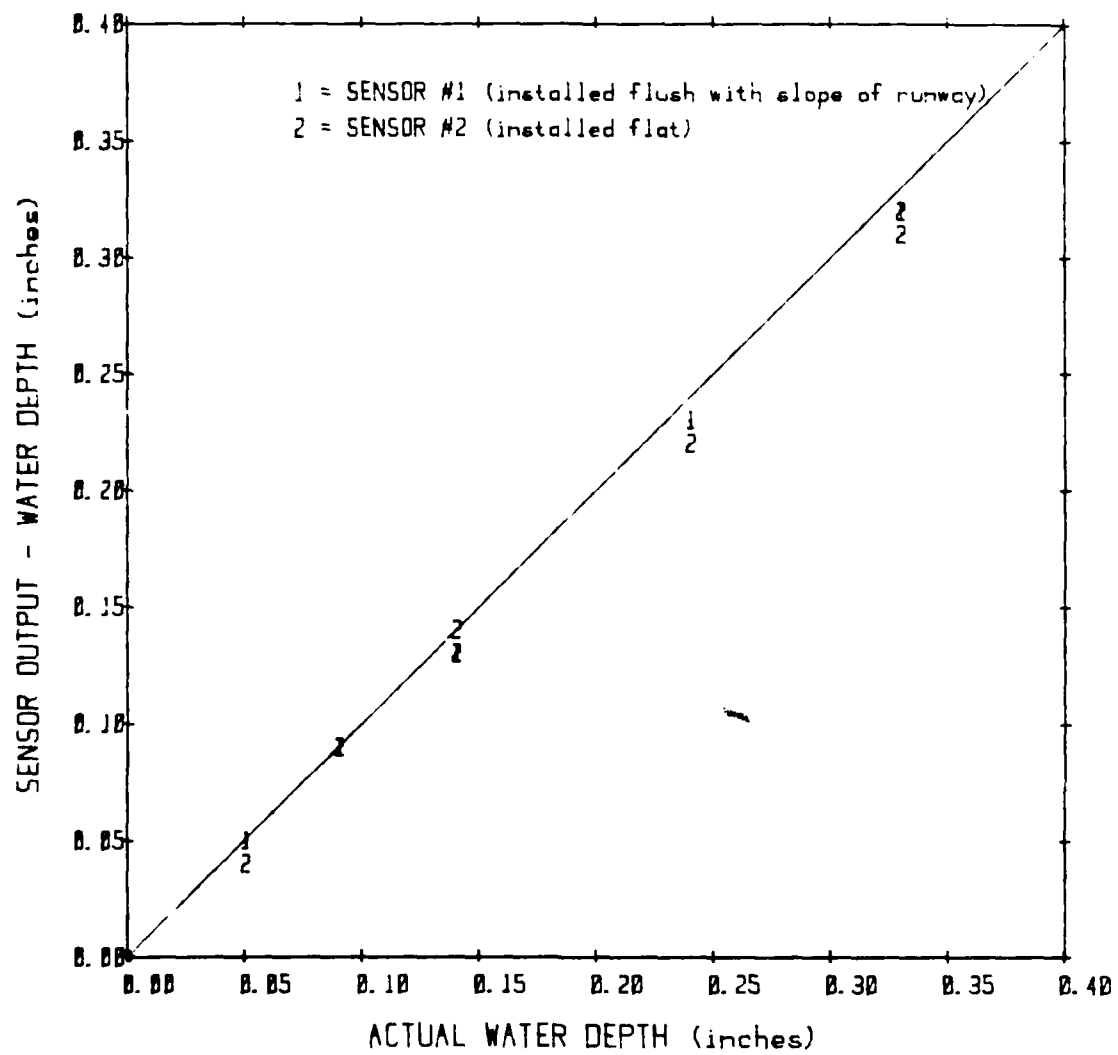
Figure 2
CALIBRATION CHECK: SENSOR OUTPUT vs. ACTUAL WATER DEPTH, 3/26/85

For the Spring 1985 experimental period, old Sensors 3-2 and 4-1 were removed and replaced with modified sensors. New Sensor-1(S1) was installed at the old 4-1 site and was mounted flush with the runway surface at an angle to the horizontal of $1^{\circ}25'$. New Sensor-2(S2) was installed approximately horizontal ($0^{\circ}6'$) at the old 3-2 site. These sensors were calibrated in the manner previously used, and the results are shown in Figure 2. As before, the sensors correctly measured the depth of a static water layer covering the sensor, which for this calibration covered the water depth range, 0.05 to 0.35 inches.

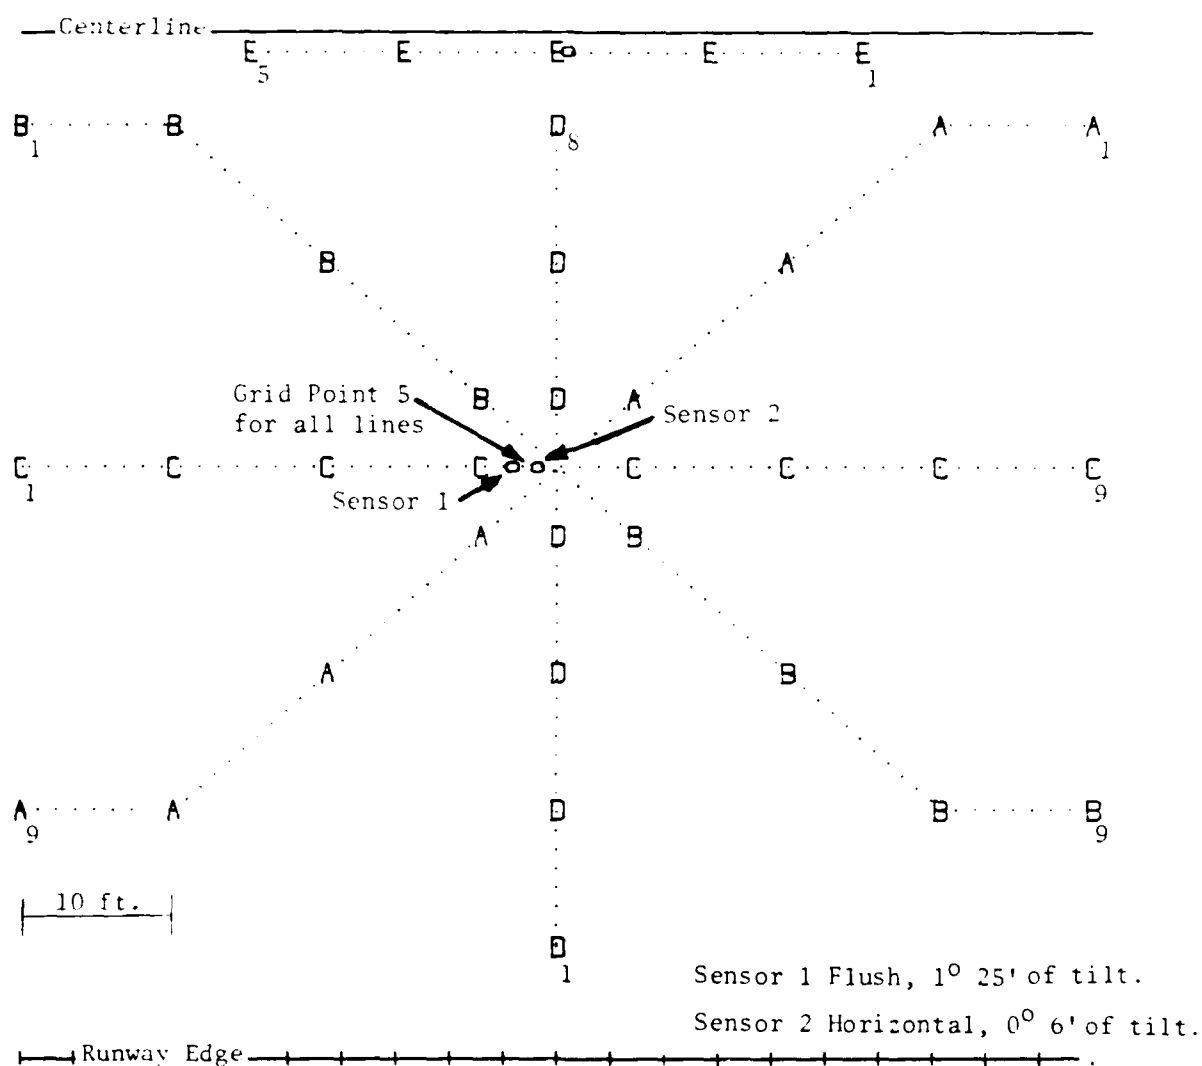
Figure 3

LINES A-E DEFINING THE MEASUREMENT GRID IN THE VICINITY
OF TWO SCAN WATER DEPTH SENSORS MOUNTED AT SPIRIT OF
ST. LOUIS AIRPORT, RUNWAY 07.

In the Fall of 1983 we painted a grid of sampling points (see Figure 3) over an area of ~ 5000 ft on the runway so that in-rain water depth measurements could be repeated at certain fixed locations using a hand-held NASA water depth gauge. In addition, the tipping-bucket rain gauge was installed approximately 800 feet to the southeast of the sensors (Figure 4).

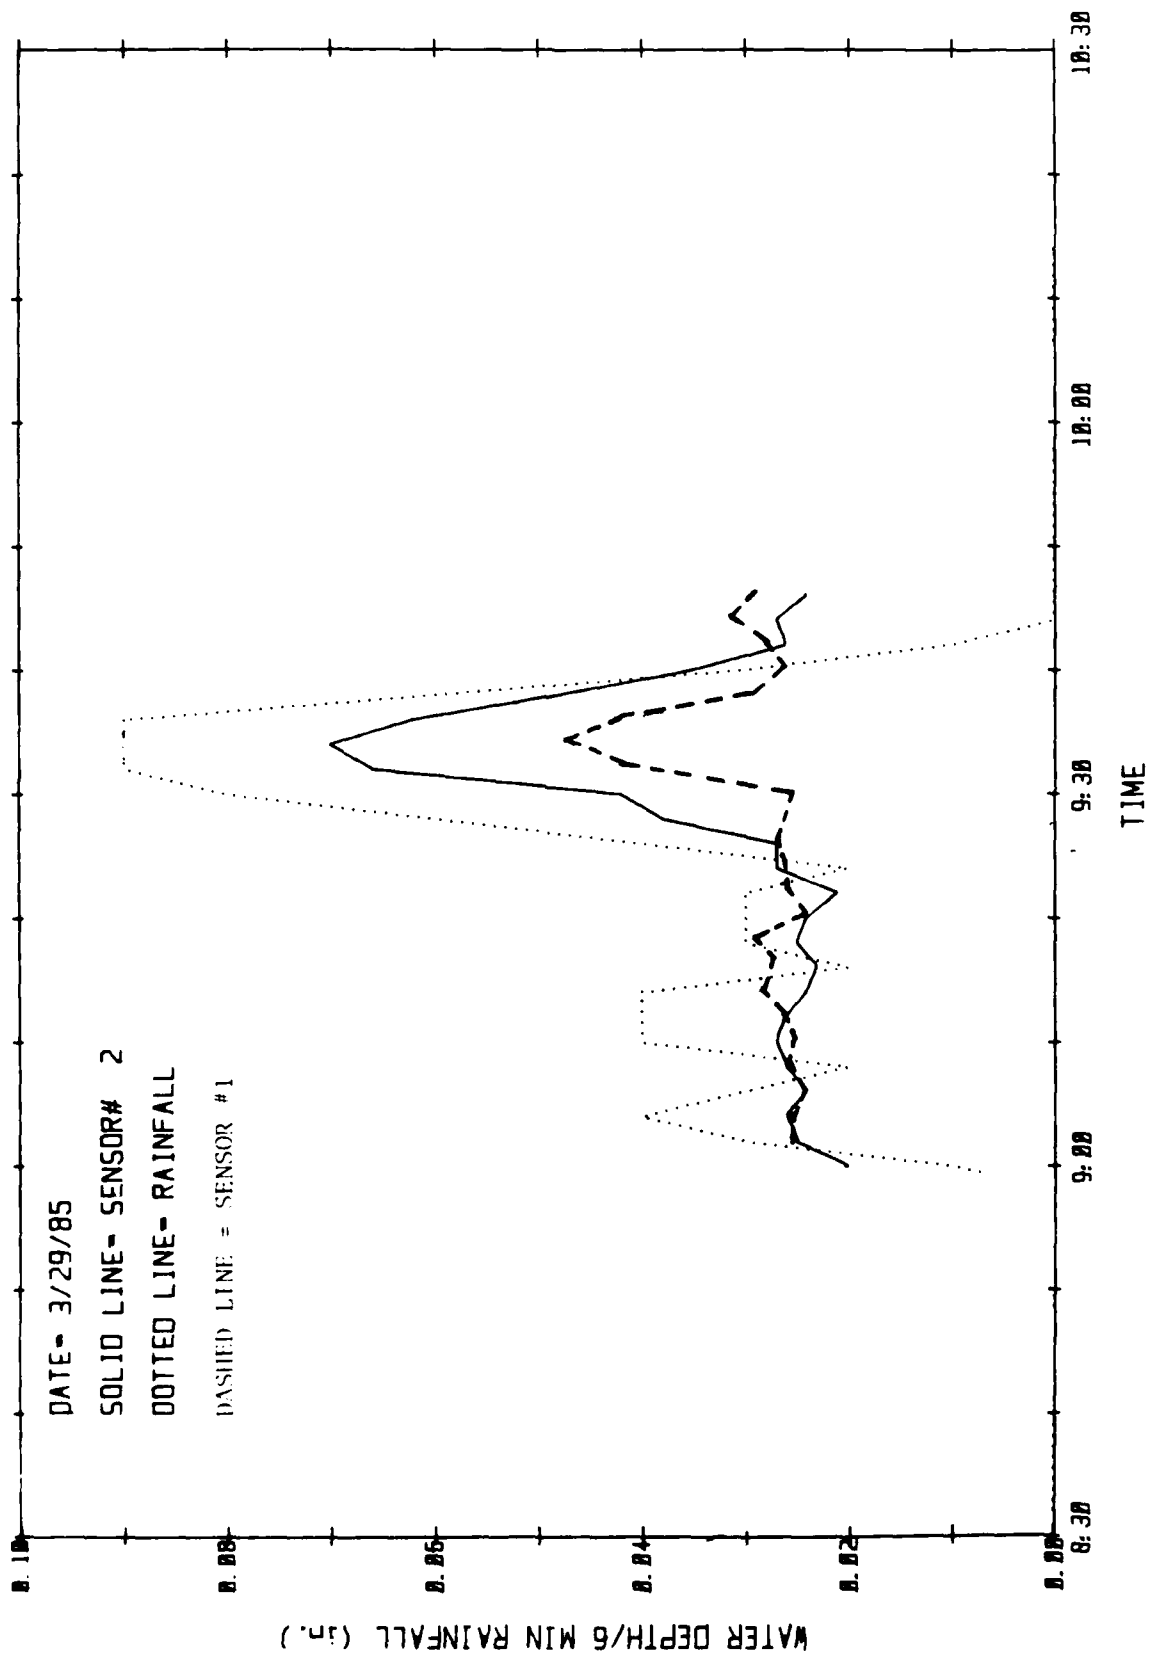
FIGURE 5 Six-minute rainfall and SCAN sensor water depths for a peak rainfall event, 29 March 1985.

Figure 5 shows a time history of Sensor 1 water depth, Sensor 2 water depth and six-minute rainfall for the time period during which the maximum depth of 0.07 inches reported for S2 in Table 1 occurred. Both SCAN water depths peak when the six-minute rainfall peaks; as well, both essentially increase and decrease in phase with the rainfall. To show detail, a portion of the data are presented in Figure 6 on an expanded time scale. In addition, Calspan, Grid Point 5 measurements which were taken during this interval are included and plotted at the midpoint of the quantum step, i.e., 0.04-0.059 inch measurement plotted as 0.05 inch. At the three earliest SCAN observation times, all three water depths are near 0.03 inches. Then, as the rainfall rises to its peak at 09:34:30, all three water depths increase more or less in parallel with the Calspan values being the largest and the S1 values being the smallest.

As pointed out in the discussion of Table 1 and of Figures 5 and 6, for water depth values ≤ 0.03 inches the two sensors measure approximately the same water depth. A Calspan set of series measurements was taken at these low water depths later on 29 March at 13:46:26 and are shown in Figure 9a. All three curves are narrow and are peaked between 0.02 and 0.03 inches. Another example from the morning set of observations is shown in Figure 9b. In this set, the Calspan observations are from various grid points sampled during the two minute SCAN observations period. In this case, the two SCAN distributions are almost identical and match the Calspan observations peaked around 0.02 inches.

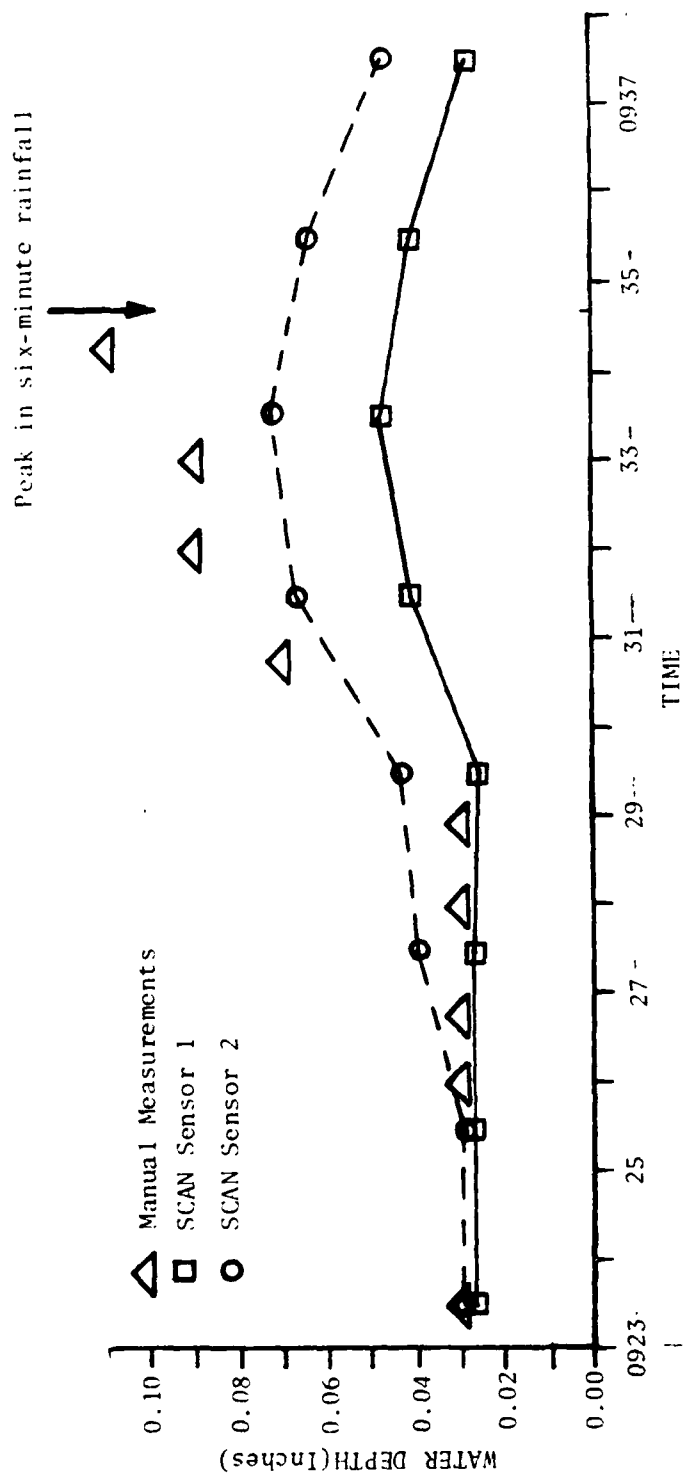
FIGURE 6 Manual, independent runway water depths and SCAN sensor water depths centered around the peak rainfall in FIGURE 5, 29 March 1985.

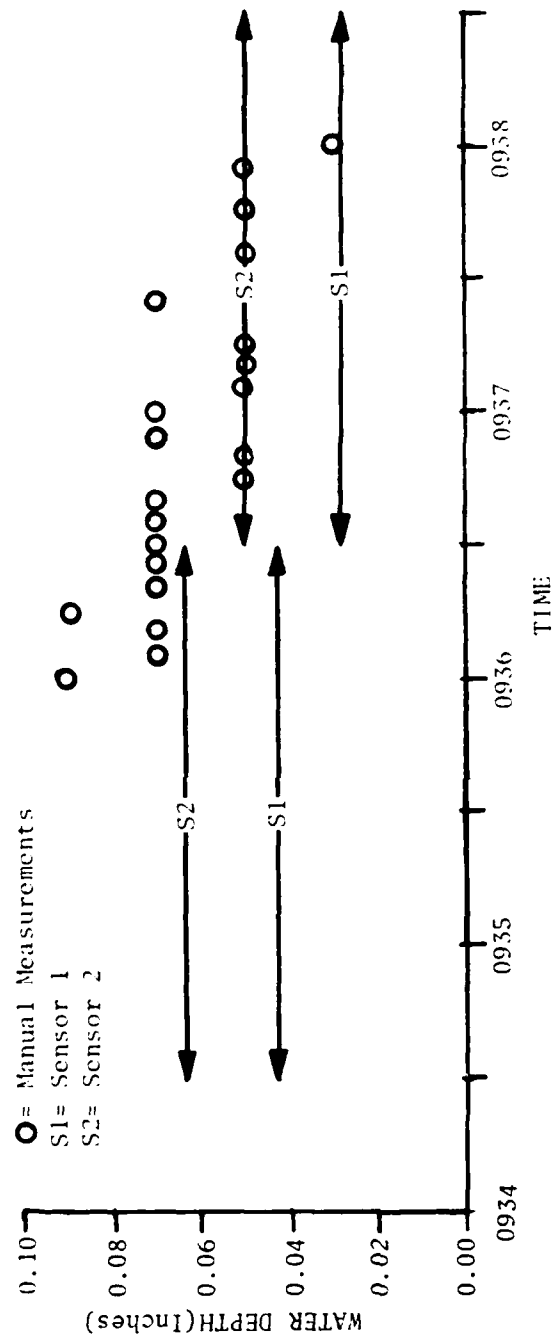
FIGURE 7 Time history comparison of individual, manual water depth measurements with SCAN two-minute averages after peak rainfall in Figure 5.

second intervals. These measurements are best compared to SCAN measurements by further expanding the time scale. In Figure 7 the Calspan data present all the individual measurements, while the horizontal bars with arrows locate the SCAN water depths and show the two-minute period for which the SCAN measurements represent averages.

Although the first six Calspan measurements cover only the last 30 seconds of the first SCAN observation period, the S2 water depth still is compatible with the lower Calspan values. However the S1 value is definitely lower than the Calspan value. The remaining 1.5 minutes of the Calpan data cover 3/4's of the second SCAN observation period. For this period, S2 matches eight of the fifteen observations. Again the S1 value is definitely lower than the Calspan value. These data suggest that S2 measured the true water depth, while S1 measured something lower.

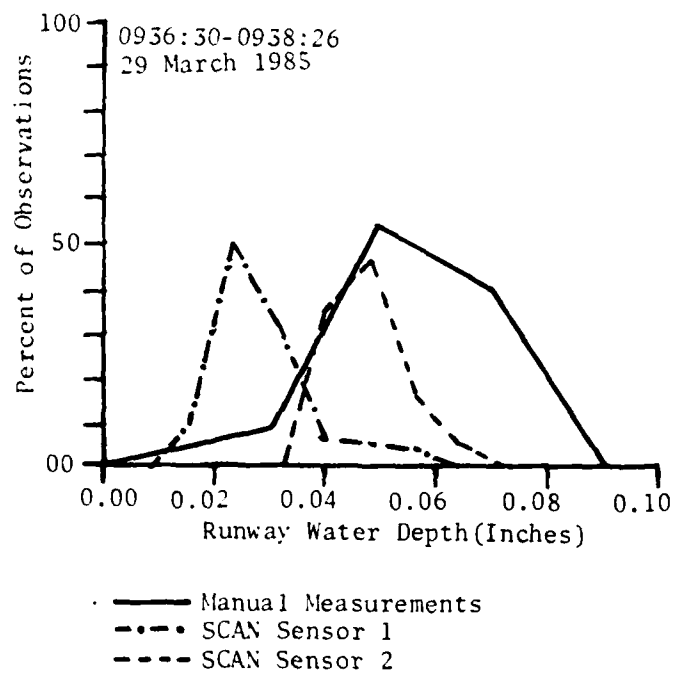
FIGURE 8 Distribution of runway water depth measurements from SCAN and manual sensors after rainfall peak at 0935, 29 March 1985.

Since the SCAN measurements are weighted means from the distribution of depths measured during the two-minute period, we compared these distributions to the "distributions" of Calspan measurements for the same time period. Figure 8 shows the distributions of water depth measurements from the three sensors. Both the S2 and Calspan curves are peaked near 0.05 inches. The S2 distribution is very similar to the Calspan distribution, remarkable considering that S2 had an enormously large number of observations while Calspan had 15. The S1 distribution on the other hand is peaked at the smaller water depth value of 0.02

inches. Thus, the distributions also support the finding that S2 reported a depth more representative of water depth on the runway between the sensors, while S1 measured something less.

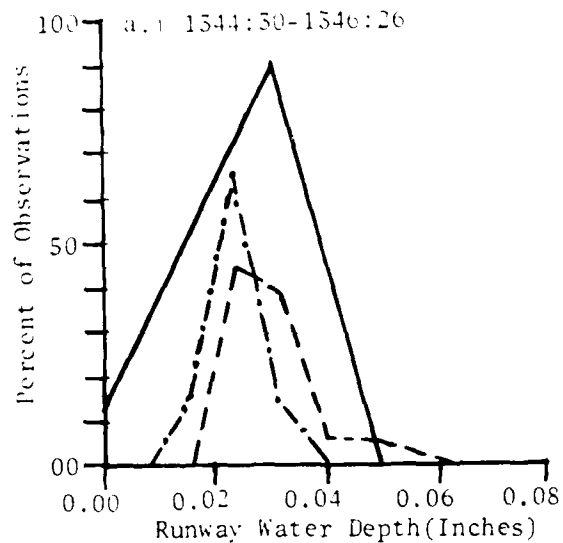
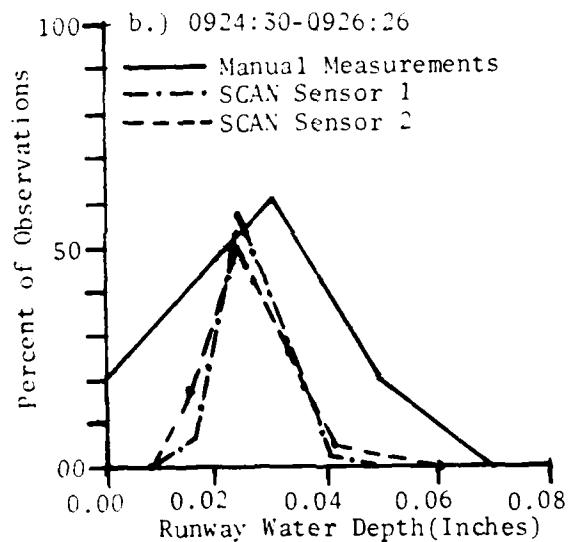
FIGURE 9 Distribution of runway water depth measurements from SCAN and manual sensors for small water depths occurring at start of rainfall events, 29 March 1985.

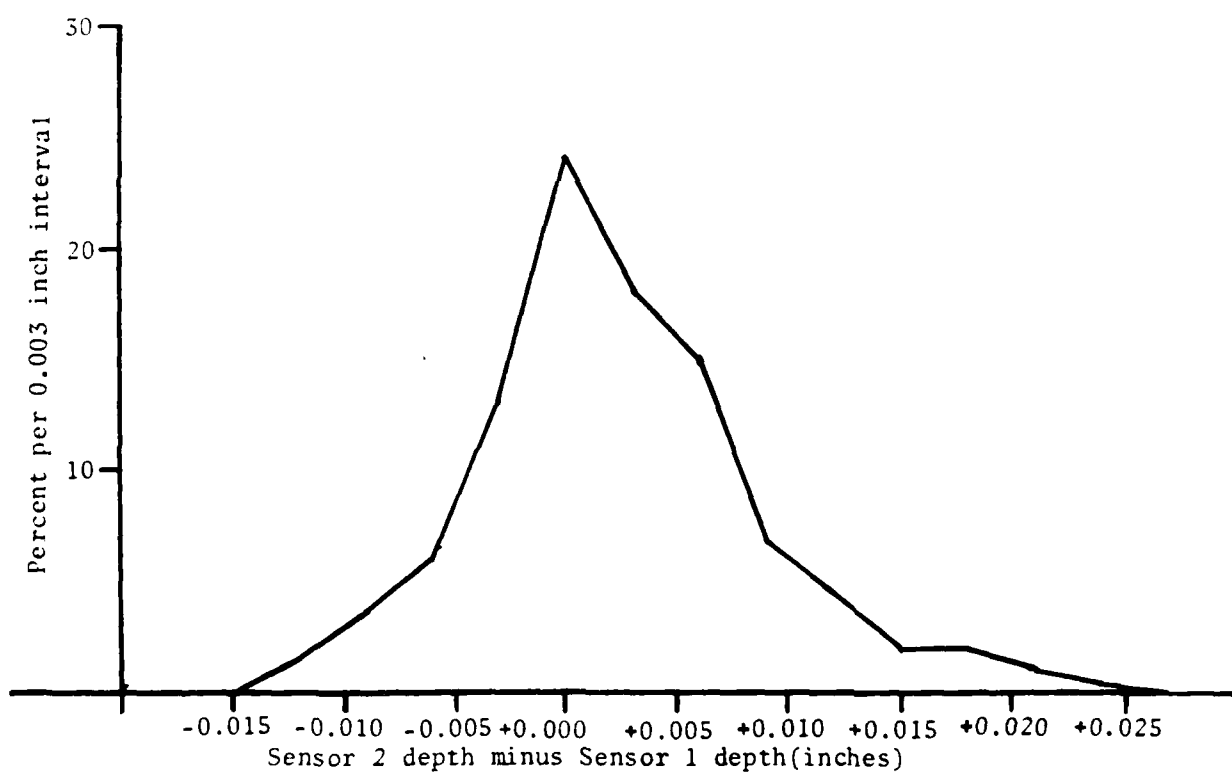
FIGURE 10 Distribution of difference between Sensor 2 water depth and Sensor 1 water depth for Spring 1985 field program.

approximately the water depth resolution of the sensors. However, the positive values of $S2-S1$ tend to have slightly higher percentages than their negative counterparts, and non-zero percentages extend to larger positive than negative $S2-S1$ values, as verified by the cumulative percentage from negative to zero being only 37%. Thus, the total distribution shows a basic random distribution of $S2-S1$ differences, but it also indicates a tendency for more positive than negative values of $S2-S1$, particularly at the larger magnitudes.

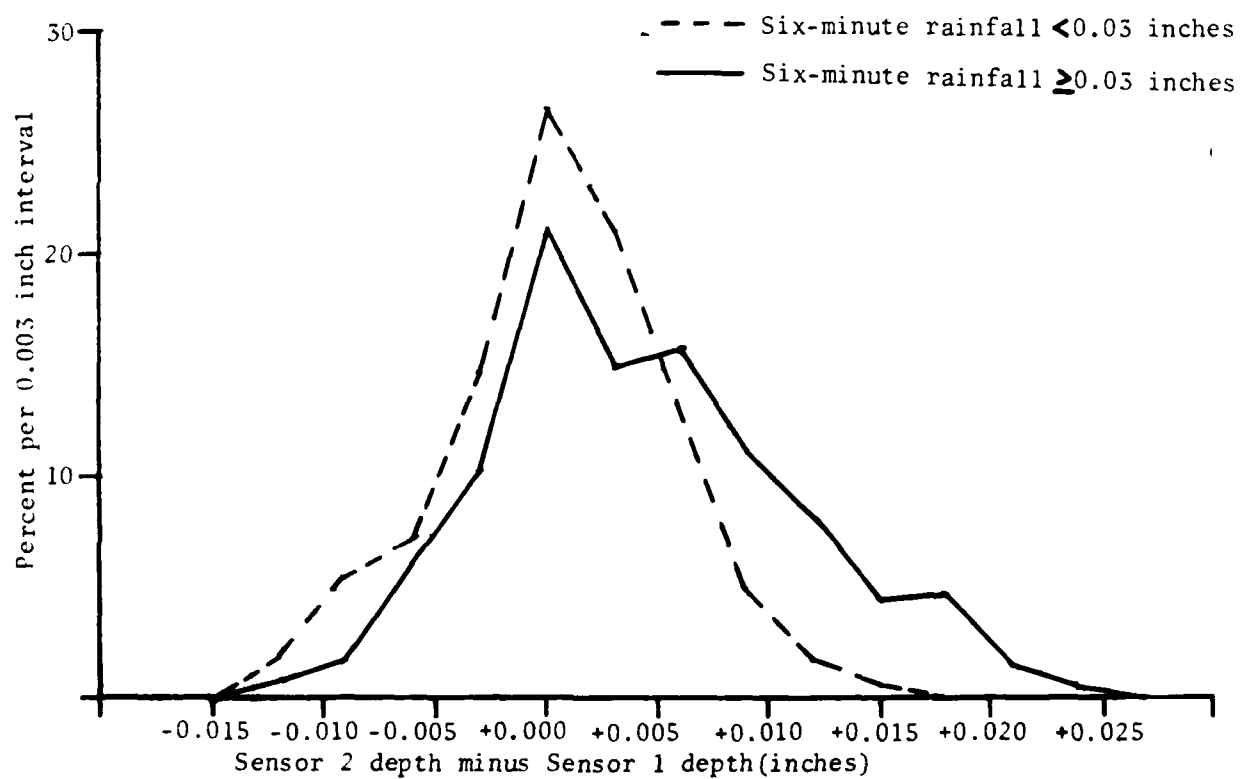
FIGURE 11 Distribution of difference between Sensor 2 water depth and Sensor 1 water depth (Spring 1985) stratified by a six-minute rainfall rate threshold of 0.03 inches.

An apparent reason for less discrimination by rainfall rate probably lies in the 800 foot separation between rain gauge and runway sensor location. Many of the rainfall events in the entire data sample were characterized by showers, and therefore it is possible for relatively large rainfall rates to have occurred at the rain gauge but not at the sensor site, even when six-minute total rainfall is used as the measure of rainfall intensity. This result suggested that we would have to use a non-independent measure for separating out high rainfall and large water depth events at the sensors, namely the water depth measured by Sensor 2 itself.

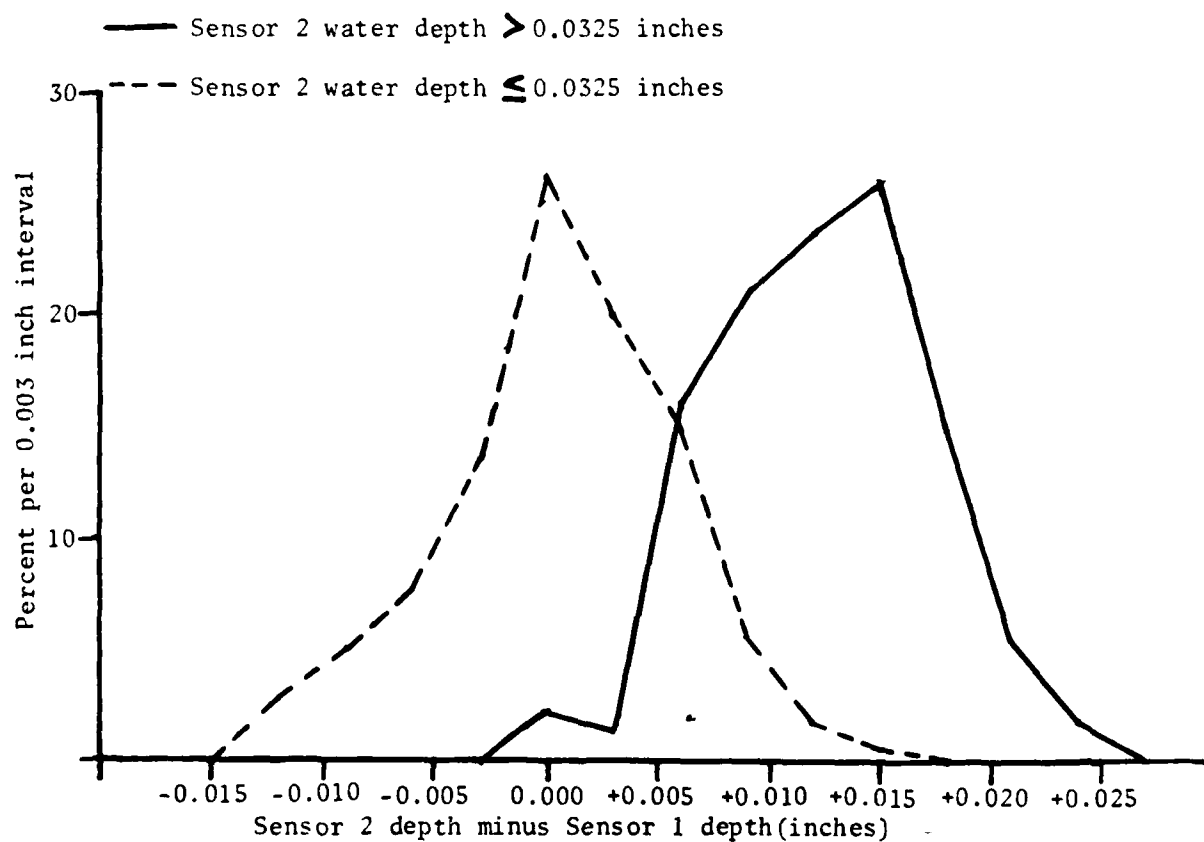
FIGURE 12 Distribution of difference between Sensor 2 water depth and Sensor 1 water depth (Spring 1985) stratified by Sensor 2 water depth threshold of 0.0325 inches.

The dividing value for S2 was chosen as 0.0325 inches and was based on examining the data set for a characteristic threshold value of S2 associated with the rise of runway water depth to moderate and large values. The two resulting distributions are shown in Figure 12. The separation into two data sets, one which is Gaussian about the zero value of S2-S1 and one which is less Gaussian, but nonetheless shows a peak in the 0.009 to 0.015 in. range, is obvious. The lack of Gaussian distribution for the >0.0325 in. distribution may be due to its smaller sample size, 80, versus 503 for the ≤ 0.0325 in. data set. The data in Figure 12 clearly show that the large differences in S2-S1 occur predominantly at the large runway water depths, and probably at the higher rainfall rates.

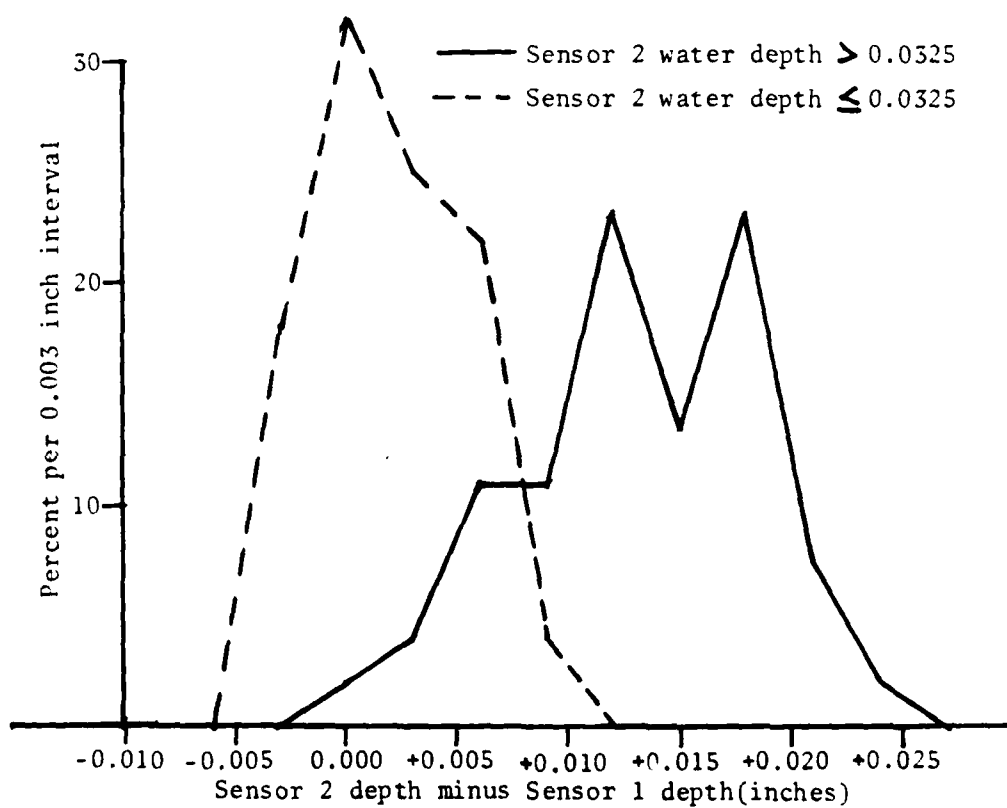
FIGURE 13 Distribution of difference between Sensor 2 water depth and Sensor 1 water depth(Spring 1985) for six-minute rainfall ≥ 0.05 inches, stratified by Sensor 2 water depth threshold of 0.0325 inches.

To further refine this discrimination by S2 water depth, we stratified the data set defined by six-minute rainfall rates ≥ 0.05 in. by the same S2 threshold, 0.0325 in. The idea was that in this shower type rainfall, the heavier the rainfall the more likely the rainfall rate at the sensor would be equal to the rate at the raingauge. As shown in Figure 13, the resulting two distributions again distinctly separate. The existence of a distribution centered around zero difference shows that even for these heavier showers, the sensor site was probably located on the shower's edge with a rainfall rate that was significantly less than that measured at the rain gauge site. On the other hand, the distribution centered around 0.015 in. no doubt represents conditions during which rainfall rate at both

raingauge and sensor site are nearly equal at values ≥ 0.05 in/6 min. Except for the local minimum at 0.015 in. (probably a small sample artificiality) this distribution indicates that for large values of rainfall rate and correspondingly large values of runway water depth there is definitely a tendency for the water depth at S2 to be 0.010 to 0.020 inches deeper than at S1.
